## **CORROSION CHARACTERIZATION OF As – CAST COMMERCIAL Al – BASED ALLOY SYSTEM IN SELECTED AQUEOUS MEDIA**

Corrosion characterization of commercial as – cast Al - based alloy has been studied in 0.1M HCl and seawater respectively. The general corrosion trend of passivating metals which aluminium belong to are generally observed but with markedly severity in the acidic environment. This behavior is attributed to the increasing electrical conductivity of the solutions; a consequence of increasing solubility of the media which progressively increased before declining due to the immobility of current carrying ions. The stress – strain test showed that there is a direct relationship between the alloy composition and, the loading force and yielding points. The microstructure analysis carried out via the optical micrographs reveal that the corrosion trend is generally homogeneous with absent of pitting or any form of localized attack in all the samples.

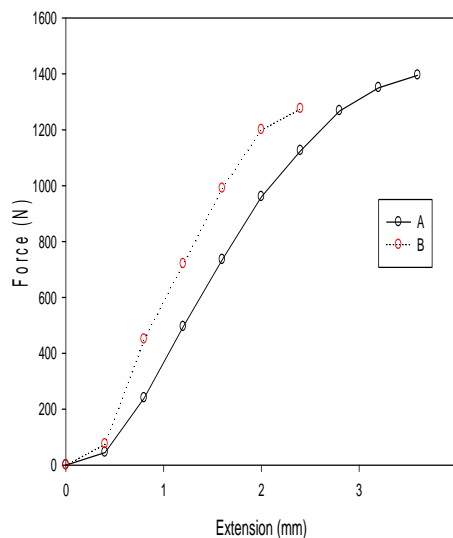
Fig. 1. Force against extension graph for the control samples

Figs. 1 – 3 show the ultimate strength against the elongation of the alloys at room temperature. It could be seen that the normal stress – strain curves for relatively ductile materials, to which aluminium belongs, were followed by all the samples in each of the media studied though with varying degree of severity.

**Strain Behavior:** A critical look at the curves shows that for the controls (fig. 1), sample **A** fractured at an extension of 3.60mm while sample **B** fractured at an extension of 2.40mm. In acidic environment (fig. 2), both samples could only extend up to 2.00mm while in the seawater environment (fig. 3), sample **A** extended up to 2.40mm but sample **B** showed somewhat lower value of 2.00mm. These behaviours suggest that there is a direct relationship between corrosion media and strain such that the presence of embrittling species in a corrosion medium reduces the ductility of the material. Also, the higher extensions exhibited by sample **A** as against that of sample **B** supports the claim that impurity atoms diminish the corrosion resistance of aluminium in aqueous media and hence strain resistance. Thus, there is a direct relationship between the alloy composition and its strain behaviour.

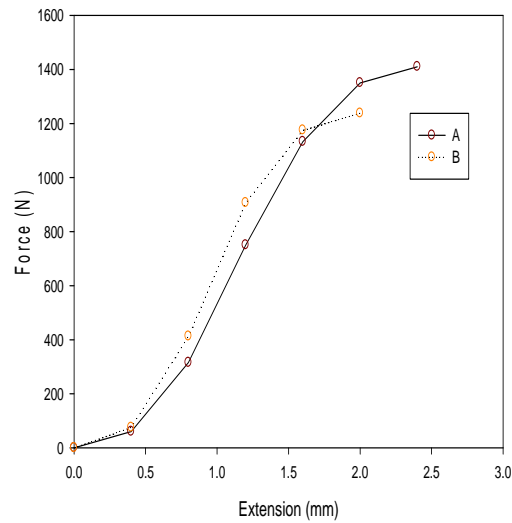
Fig. 2. Force against extension graph for the samples in seawater

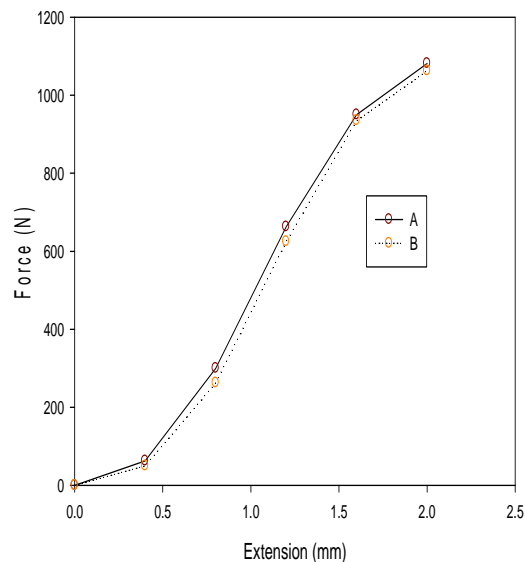
Fig. 3. Force against extension graph for the samples in 0.1M HCl.

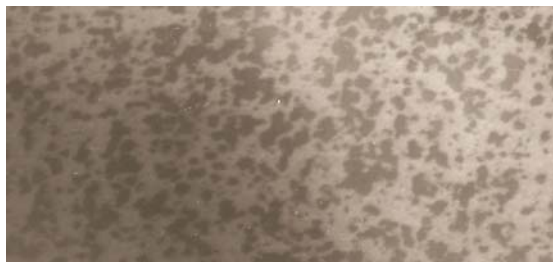
*Plate 1: Micrograph of control Sample A*

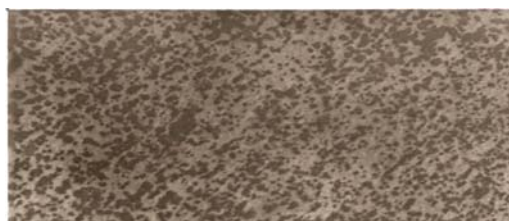
*Plate 3: Micrograph of Sample A after 120h in 0.1M HCl*

A cursory look at the photomicrographs (produced at  $\times 125$  magnification) show that the samples in both environments: acidic medium and seawater were significantly affected by corrosion attacks which penetrated into the internal structure of the alloys. The morphologies show attacks that are of the general corrosion type, which was uniformly distributed over the entire surface. There was no noticeable evidence of pitting or localized corrosion attacks. The obvious implication of this observation is that the alloys formed very strong passive films that were chemically stable and widespread over the surface of the samples, hence providing high resistance against penetrations or perforations by corroding species in the media. It can be inferred that as the exposure time increases, the precipitation of the samples also increases. This can be seen from the grain boundary distribution which increased with exposure time.

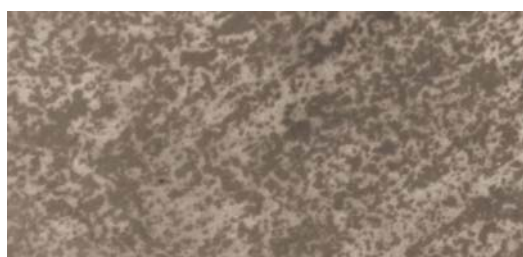
*Plate 4: Micrograph of Sample A after 360h in 0.1M HCl*

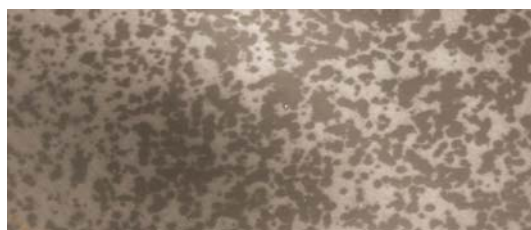
*Plate 5: Micrograph of Sample A after 720h in 0.1M HCl*

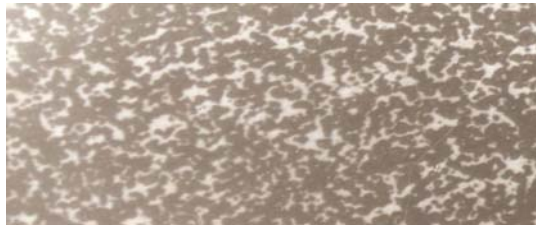
*Plate 6: Micrograph of Sample A after 120h in sea water*

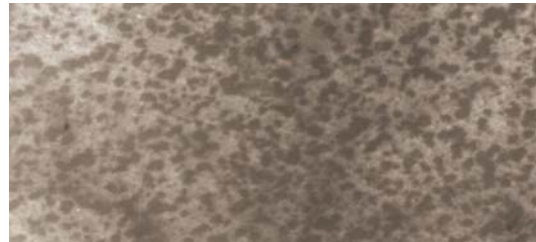
*Plate 7: Micrograph of Sample A after 360h in sea water*

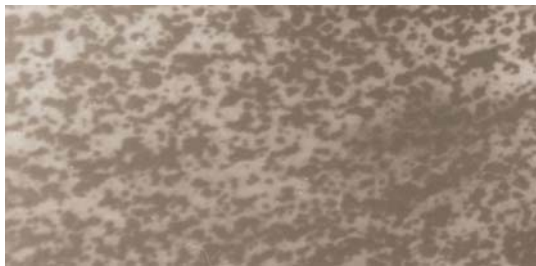
*Plate 8: Micrograph of Sample A after 720h in sea water*

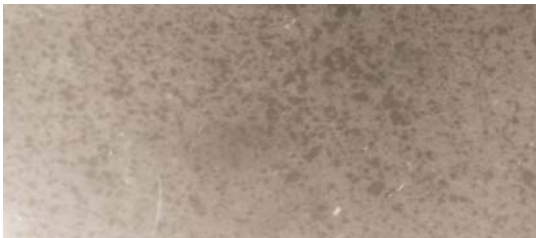
*Plate 9: Micrograph of Sample B after 120h in 0.1M HCl*

However, the attacks were most severe in sample **B** than **A** in both environments being characterized. This again supports the fact that impurity atoms diminish the corrosion resistance of aluminum. As would be expected, the samples exposed to the acid medium were more prone to attacks than those in seawater. Generally, theoretical assertions suggest that the presence of halides in seawater normally accelerates pitting corrosion because they have the potentialities of penetrating through the passive film creating perforations in the material. The absence of such perforations or pitting sites in this study suggests that the material formed passive films ( $\alpha$  – alumina) that were resistant to the effects of halides, which are imperative constituents of known seawater.

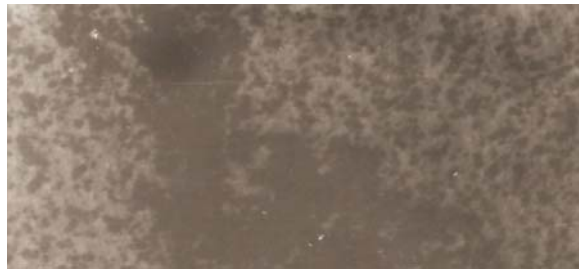
*Plate 11: Micrograph of Sample B after 720h in 0.1M HCl*

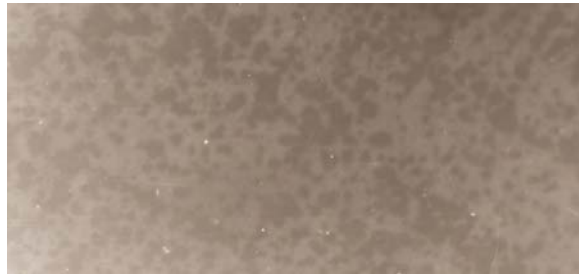
*Plate 12: Micrograph of Sample B after 120h in sea water*

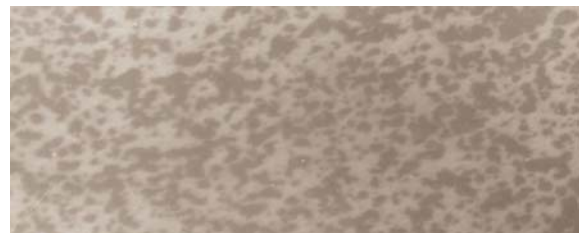
*Plate 13: Micrograph of Sample B after 360h in sea water*

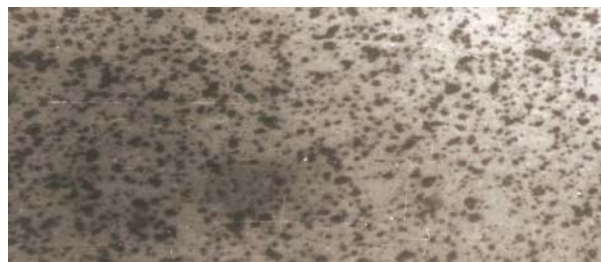
*Plate 14: Micrograph of Sample B after 720h in sea water*
